**REPORT**  
**MRL-R-956**

**WELD REPAIR OF CRACKED DEFA**  
**CANNON MOUNT FRAMES**

The weld repair of fatigue cracks found in the mounting frames of the Defa gun pack, fitted to Mirage III aircraft, is described. These cracks, caused by normal gun firing stresses, occurred well short of the frame design life as a result of metallurgical degradation in the form of a decarburized layer on the surface of the cast steel frames.

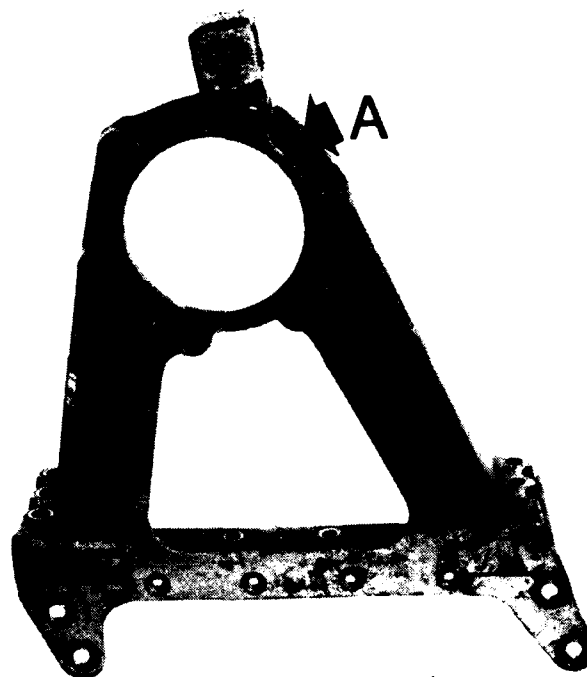
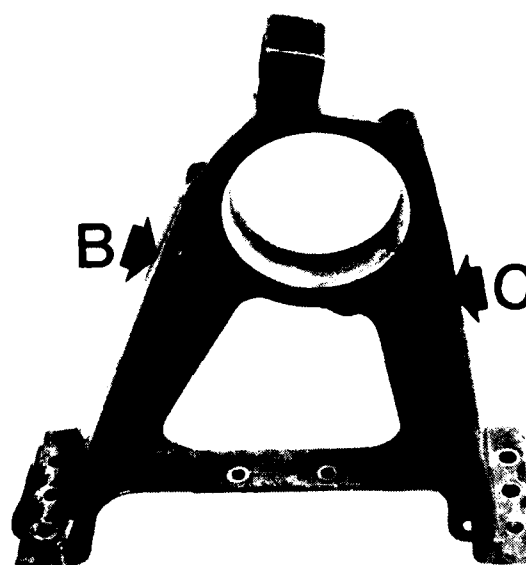
FIGURE 1

Previous inspection of cracked frames at MRL had shown that even the most severe cracks were repairable. All cracks in positions A, B and C (Fig. 1) were therefore weld repaired, regardless of size. Cracks were ground out using specially shaped tungsten carbide cutting burrs in a pneumatic rotary grinding tool. In this crack removal operation a 'U' shaped groove with tapering sides was required as the most suitable repair preparation. This geometry was chosen to minimize the possibility of lack of side wall fusion during subsequent welding.

- (i) Cracks were totally removed where they had not propagated through a complete section. This situation commonly arose at position A, Fig. 1. During the process of crack removal it was frequently necessary to check for complete elimination of the crack using the fluorescent magnetic particle technique.
- (ii) Where crack had propagated through a section, as could occur in position B (Fig. 1), 0.5 mm of metal was left to help support the subsequent weld root run. The aim here was to completely fuse out the remaining crack in the first root pass. The weld preparation to achieve this is shown diagrammatically in Figs 3. A grooved copper backing strip, especially manufactured for this operation, was used for additional support during welding (Fig. 4).

Location of cracks in Defa front mount frames. Cracking was most common in sites A and B.

In the case where cracking had occurred at only one or two of the identified recurrent sites, preventative action was taken to delay fatigue crack initiation at the remaining sites (Fig. 1), by coarse polishing over an area about 30 mm across using a pneumatic rotary polishing wheel, followed by fine hand polishing. A final fluorescent magnetic particle inspection was then applied.

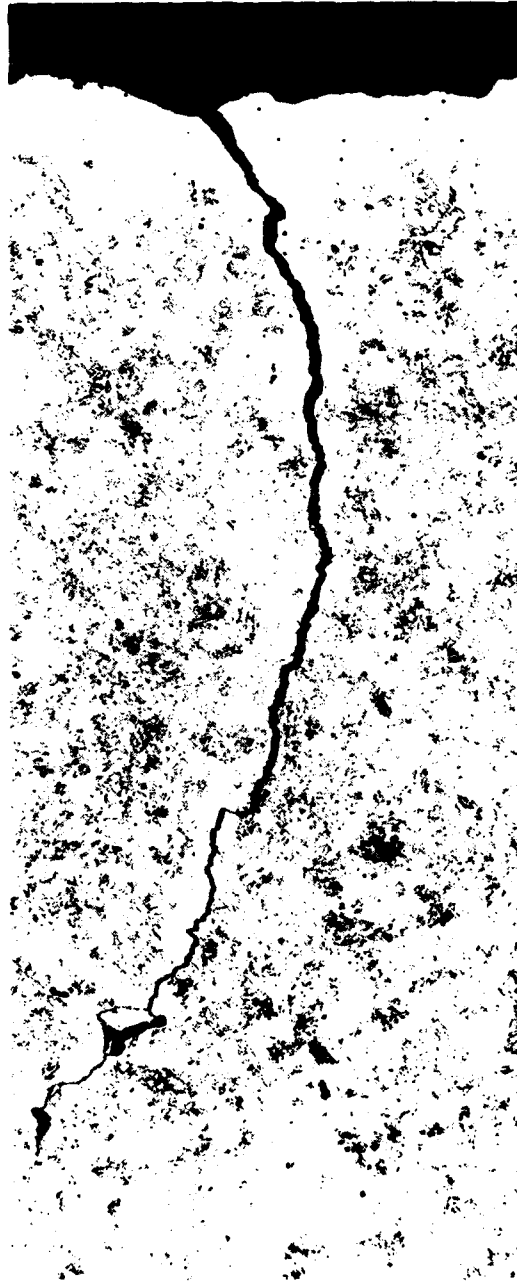
FIGURE 2

1. The upsurge in the incidence of cracking in these front mount frames has been identified as fatigue cracking caused by the harmful effect of a decarburized layer on the surface of the heat-treated steel castings.

Initiation of a fatigue crack in the decarburized surface layer of a frame.

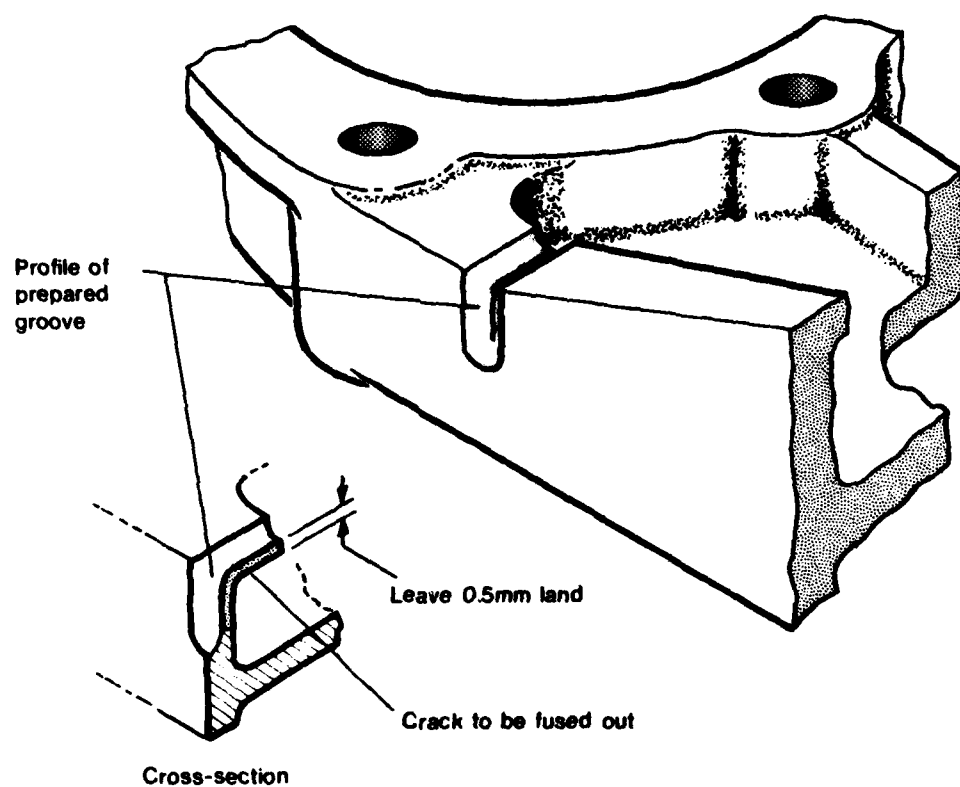
FIGURE 3

Recommended weld preparation for through-thickness cracks in position B, shown in Fig. 1.

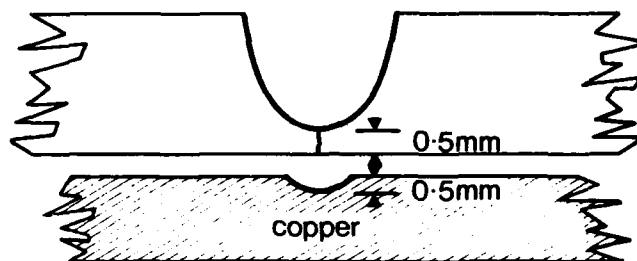
FIGURE 4

Schematic diagram of weld preparation and copper backing strip for through-section cracks.

For the welding of through-section cracks, using the grooved copper backing strip, care was taken not to fuse the copper during welding. This was achieved by first fusing the remaining crack in a carefully executed root pass. The weld was then allowed to cool to about 200°C before the filling pass was deposited.

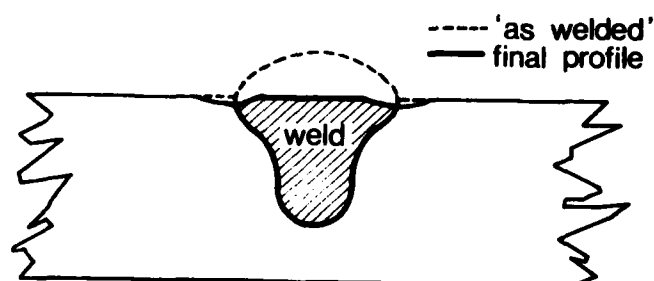
FIGURE 5

Schematic diagram showing blending out in weld toe areas.

The weld reinforcement was then ground off using tungsten carbide cutting burrs and the weld toe areas carefully blended out as shown in Fig. 5. A pneumatic rotary polishing wheel was used in the final blending-out operation. This polishing was done to minimize the propensity for crack initiation in the region of the weld toe, a common site for fatigue cracking, where the geometric notch effect of machining grooves and fusion boundary is compounded by the metallurgical notch effect of the weld.

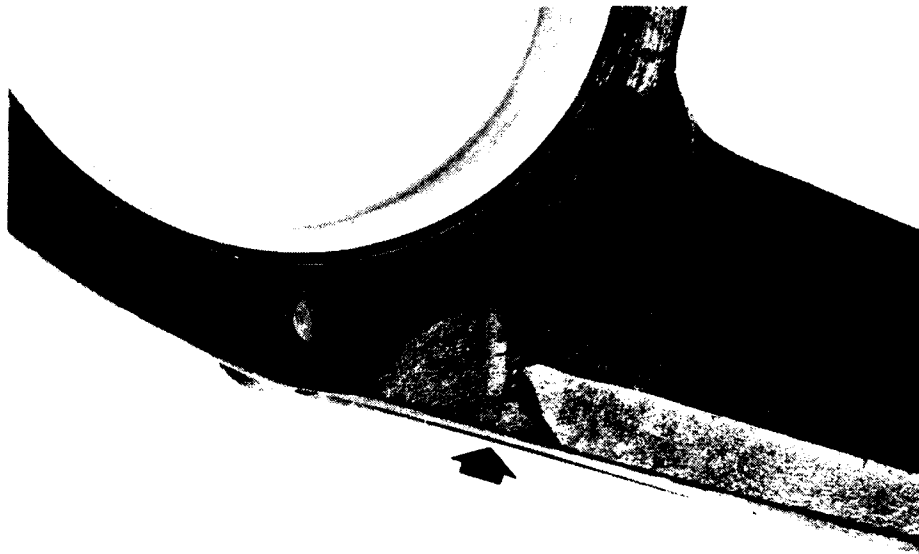
FIGURE 6

Analysis was undertaken on one crack, labelled B in Fig. 1, and shown more clearly in Fig. 6.

Detail of the crack shown at B in Fig. 1. The section shown had been subjected to bending stresses across the crack (arrowed), causing flexure convex to the plane of the page. The crack initiated at a machining groove, at the periphery of the machined surface.
